# *Renovating the Interior of Province House, Prince Edward Island*

*John Way*

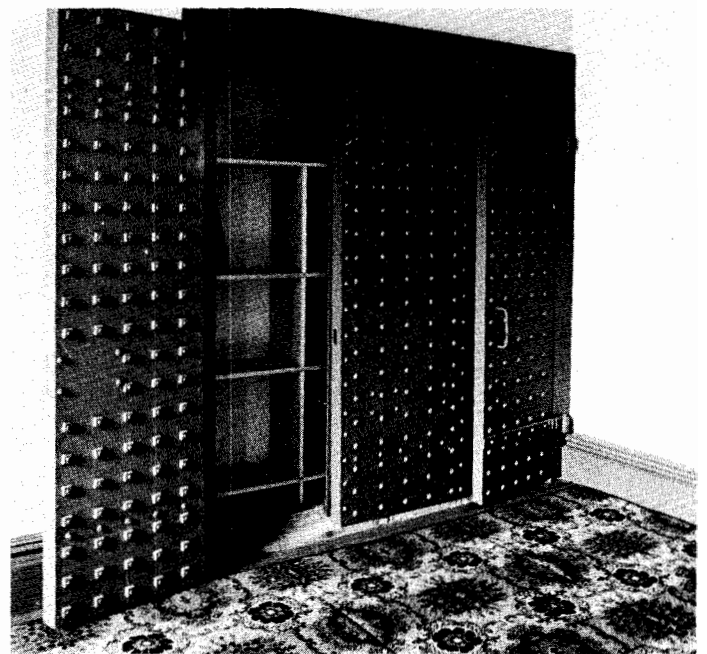
In one description of the building six fireproof vaults were specified but only five could be located, all on the ground floor. This remained a mystery until a built-in bookcase and the surrounding plaster was removed exposing an 18" deep recess in the wall surrounded by cut stone. This was the location of the sixth vault and was restored using new fireproof doors.

**One of six fireproof security vaults uncovered during restoration.**

process. The fire proof book vault required a new set of doors and special hinges. The vault doors of the 1864 period were approximately four inches thick made up of two sheets of quarter inch steel held apart by bolts at approximately eight inch centres over the entire face of the door. The doors were made in a metal fabrication shop and installed in the original stone surround on metal printle type hinges. The end result was a successful fireproof set of doors.

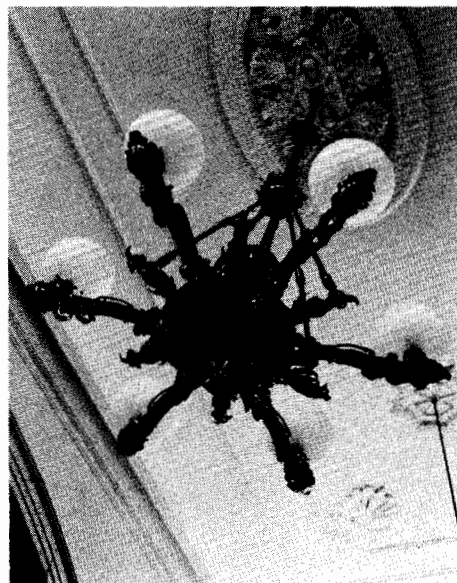
**Restored light fixture and plaster medallion in Confederation Chamber.**

Decorative plaster features such as ceiling mouldings and lighting medallions and repairs to existing medallions were also completed. These special features required the use of special "older" methods of workmanship in order to achieve the required final finish. Special mouldings and features were built up with many layers of plaster until the final shape or profile could be sculpted. The mix for the plaster was as originally specified in the 1850s and included the slaking of lime on site, an unusual procedure for today's plasterwork.

Lighting fixtures in restored areas were replaced and new period reproduction chandeliers and wall fixtures were added in the locations of the gas fixtures. The design of fixtures was based on some original fixtures which were restored and re-wired and other types of fixtures of that particular period.
